# Arboricultural Report

Tree Survey,  
Arboricultural Impact Assessment &  
Arboricultural Method Statement

In relation to the Large-Scale Residential Development at:  
**Lands within the townlands of Newtown and Confey**  
**Leixlip**  
**Co. Kildare**

**240920-PD-11-A**

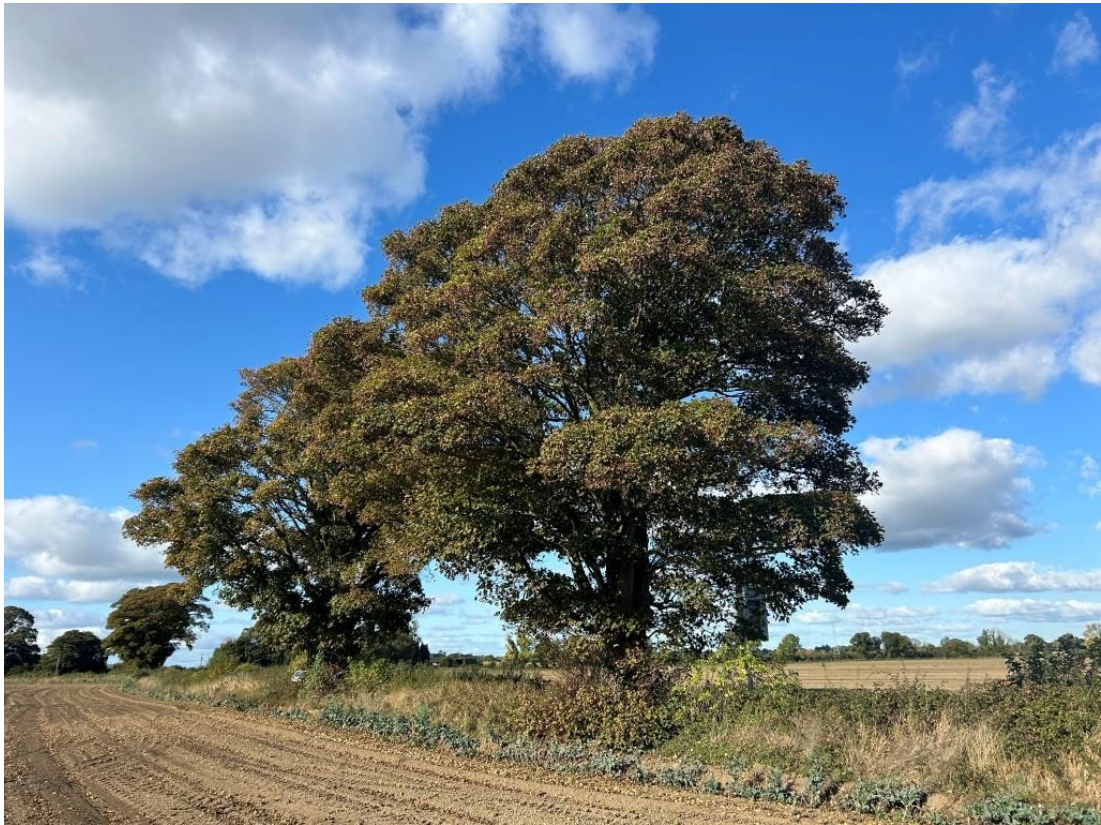
**Image 1:** View of the mature sycamore trees T93 and T92 located along the northern boundary of the site.

- 6.8 **New hard standing within tree RPAs** – The proposal will require the construction of footpaths and cycle paths within the RPAs of retained trees T65, T92, T93 and T94, as highlighted in purple on the Tree Protection Plans at Appendix B. To minimise damage or loss to the roots of trees, these areas of hard standing are required to be constructed using a no-dig design.

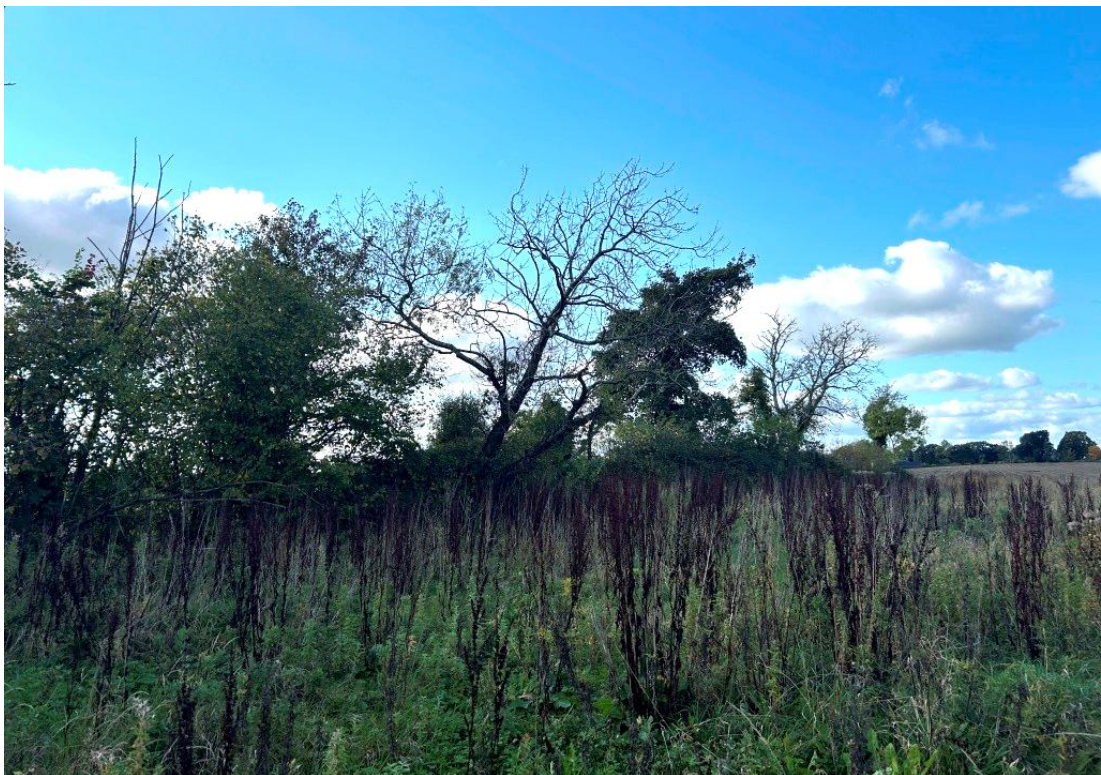
**Image 2:** View of the tree and hedge line (T73 to T100) located along the existing ditch.

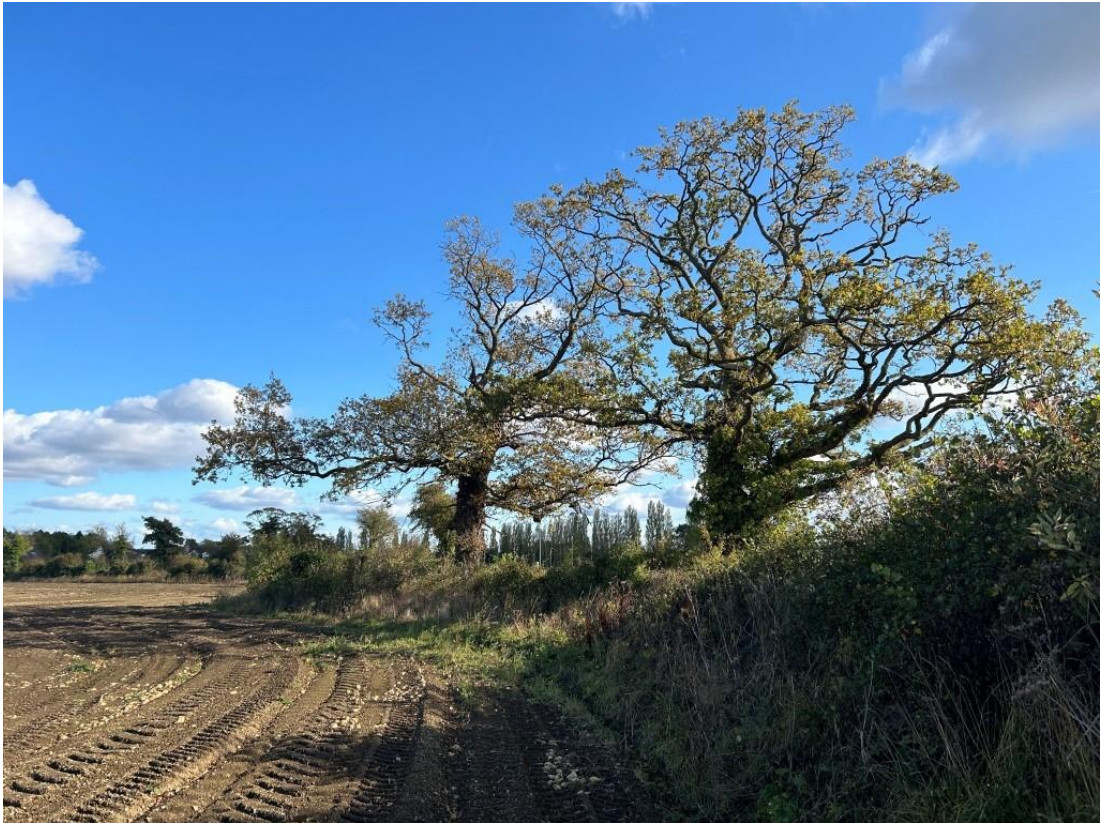
**Image 3:** View of the mature oak trees (T64 and T65) located along the existing ditch running through the centre of the site.

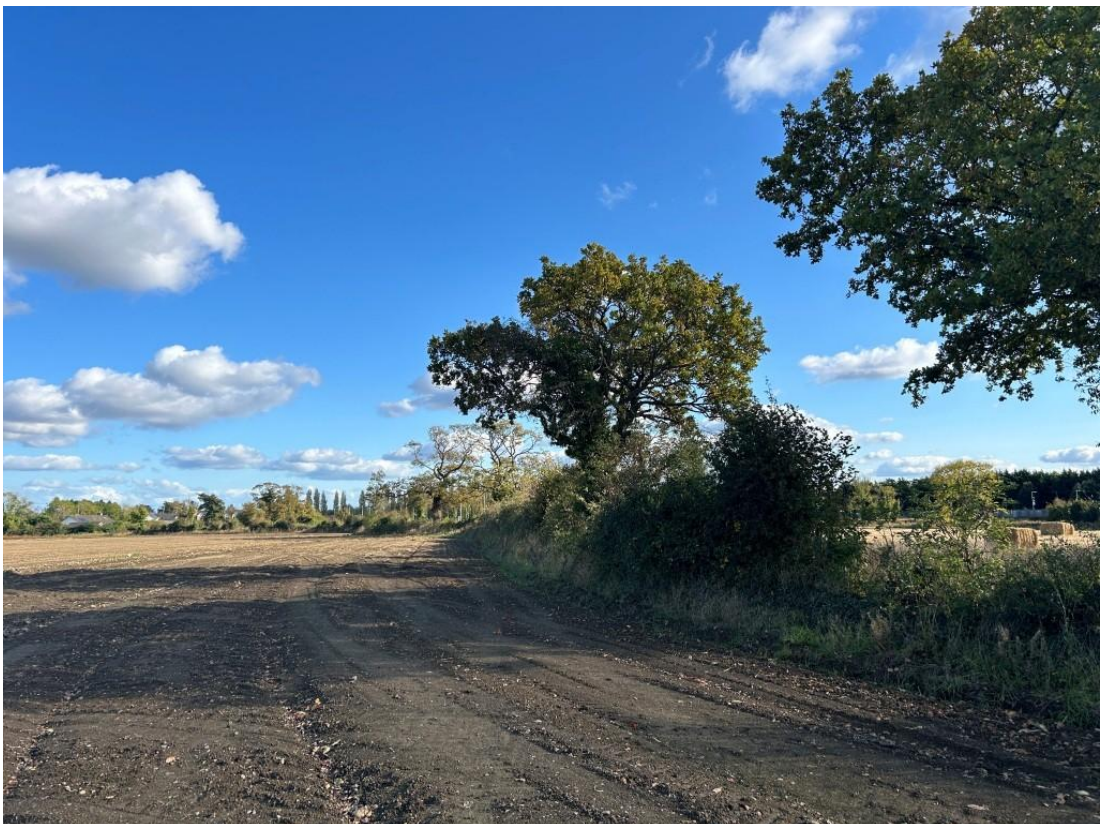
**Image 4:** View of the central hedgerow H103 and oak trees T62 located along the existing ditch running through the centre of the site.

- 7.8 The proposal has been designed to retain the southern hedgerow adjacent to the canal and remove sections of the central hedgerow for new drainage works. Within the Leixlip Local Area Plan, the central hedgerow has been classified as high-quality. Where sections are to be removed, replacement planting has been proposed.
- 7.9 The proposal has been assessed in accordance with best practice BS5837:2012 and provided the recommendations as detailed within this report are followed, all retained trees can be successfully protected for the duration of construction.
