# Confey Lands 1A LRD

## Combined Stage 1 & 2 Road Safety Audit

Ballymore Ireland Contracting Services Limited

April 2026

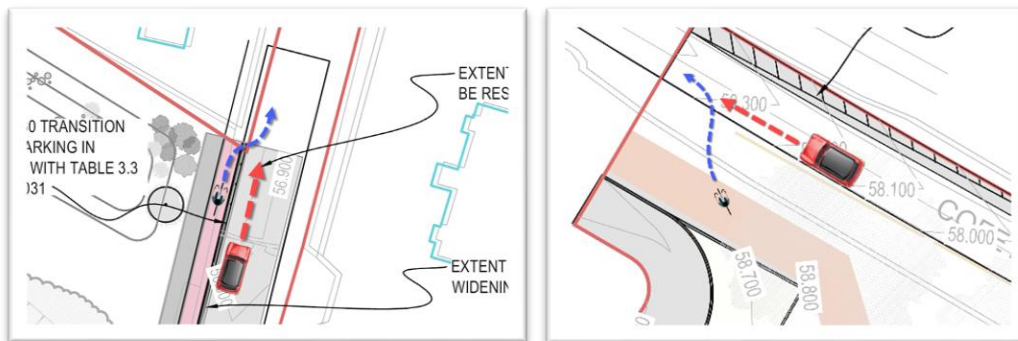
**Figure 2.1 – Locations of Where Cyclists Will Be Required Transition Back into Traffic Lanes**

**Location:** Cycle Tracks on R149 Captains Hill and L1015 Confey Road

When cyclists reach the end of the segregated cycling tracks, they will merge into adjacent traffic lanes unexpectedly, which could increase the risk of them being struck from behind by approaching vehicles.

#### Recommendation

Cyclists should be provided with a safe and appropriate means to transition back into the adjacent traffic lane. The measures should highlight to drivers the location where cyclists will be re-entering the traffic lane in front of them.

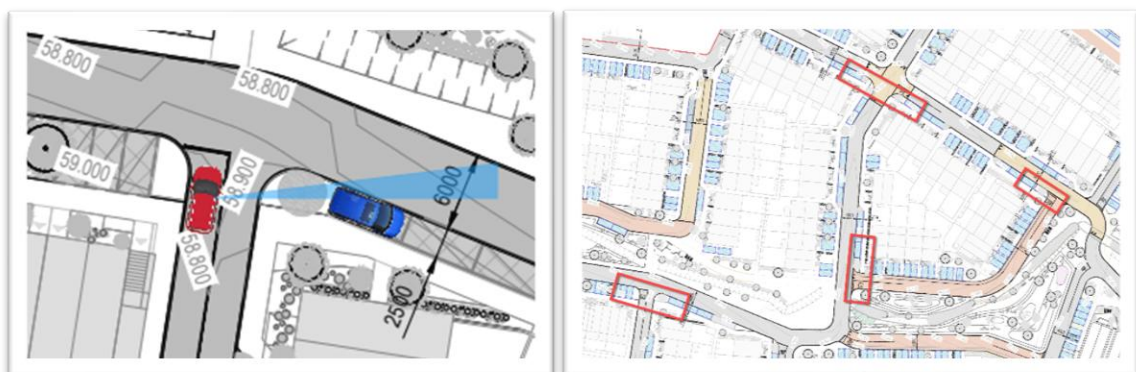
**Figure 2.2 – Examples of Internal Junctions with Parking Close By Which Might Impact on Sightlines**

**Location:** Various Junctions within the Development Internal Streets

Parking bays positioned too close to internal junctions may reduce visibility splays, increasing the risk of side impact type collisions on the internal streets.

#### Recommendation

Sightlines for all internal junctions with parking close by should be examined, with the parking arrangements modified as appropriate to achieve suitable sightlines.

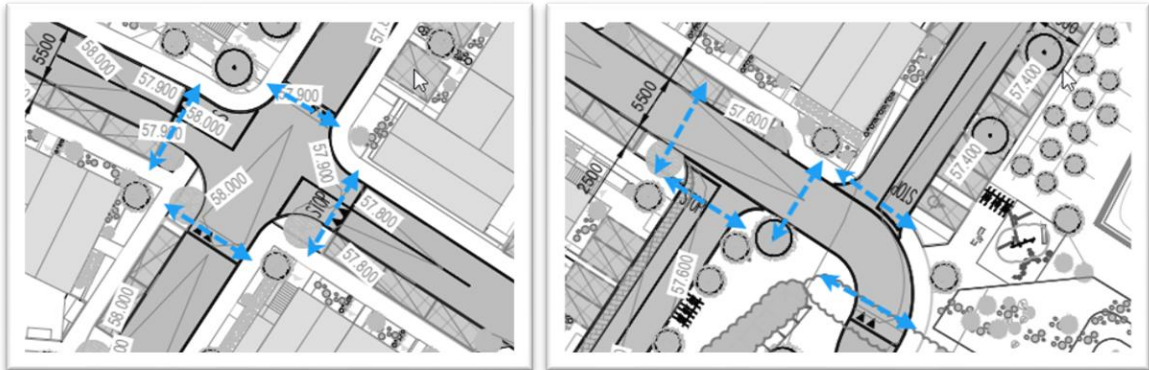
**Figure 2.3 – Uncatered Pedestrian Crossing Desire Lines at Internal Junctions**

**Location:** Various Junctions within the Development Internal Streets

At a number of internal junctions there appears to be an absence of crossing facilities. This could lead to pedestrians attempting to cross the road at unsuitable locations placing them in conflict with vehicles.

### Recommendation

Suitable raised pedestrian crossings should be provided in all locations where pedestrians are likely to want to cross the internal streets.

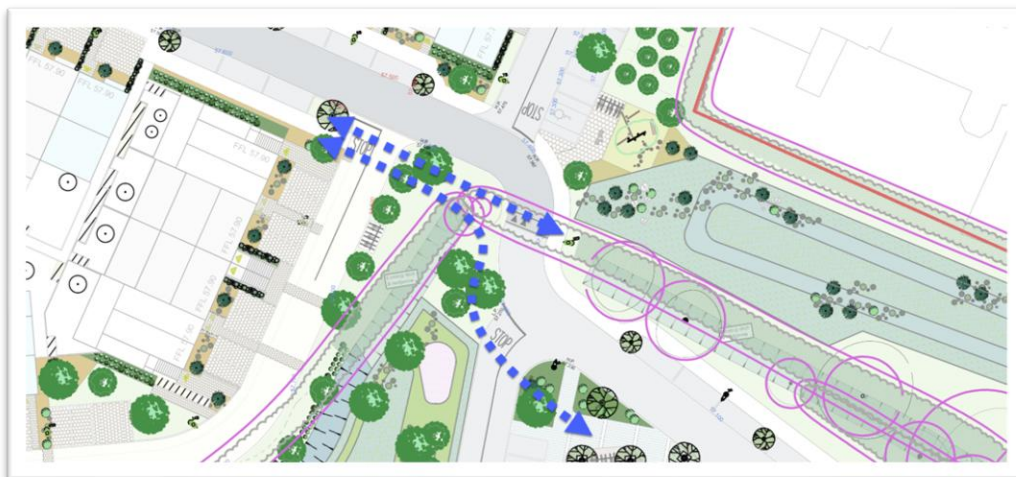
**Figure 2.4 – Missing Footpath Links Near Main Pedestrian Access to Captains Hill / Train Station**

**Location:** Internal Junction Near Access to Captains Hill

The absence of suitable footpath connections here could lead to pedestrians stepping into the adjacent traffic lane without warning. It could also lead to slips and trips for pedestrians attempting to walk in the grass to reach the nearest available footpath connection.

### Recommendation

Suitable footpath links should be provided here, including raised crossings where required.

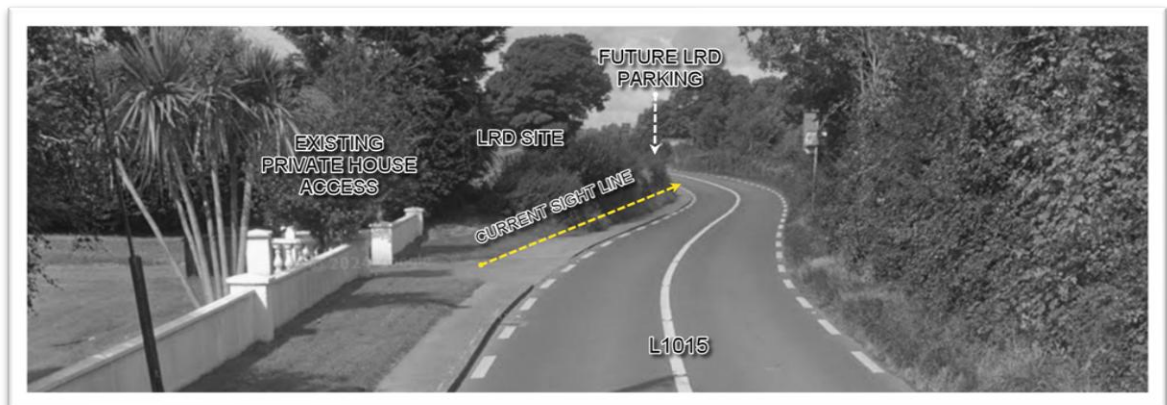
**Figure 2.5 – House Access onto L1015 & Location of Roadside Parking to Wset**

**Location:** Existing House Entrance on L1015 Confey Road

The location of the proposed roadside parking on L1015 Confey Road may reduce visibility for drivers emerging from the house access. This could lead to a collision between vehicles on L1015 Confey Road and a vehicle attempting to leave the house access.

### Recommendation

The Designer should ensure that the proposed roadside parking does not reduce visibility for drivers emerging from the house access.

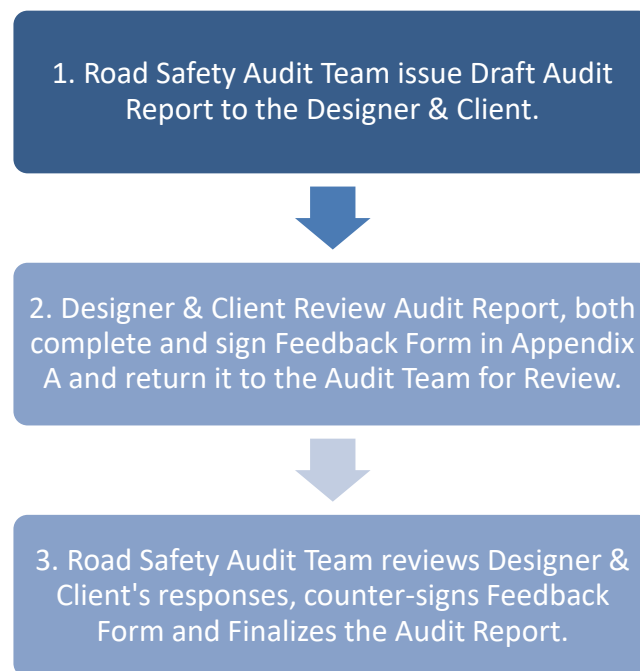
Figure 4.1 – Road Safety Audit Sign-Off and Completion Process

When completed, this form should be signed by the Designer and the Client and returned to the Audit Team for consideration. See flow-chart following for further description.
