## **Confey Phase 1A LRD**

RFI Response to Items 1, 4, 5, 6, 7, 8, 9, 10 &  
12(c) KCC Reg Ref: 26/60746

2423-DOB-XX-SI-RP-C-0004

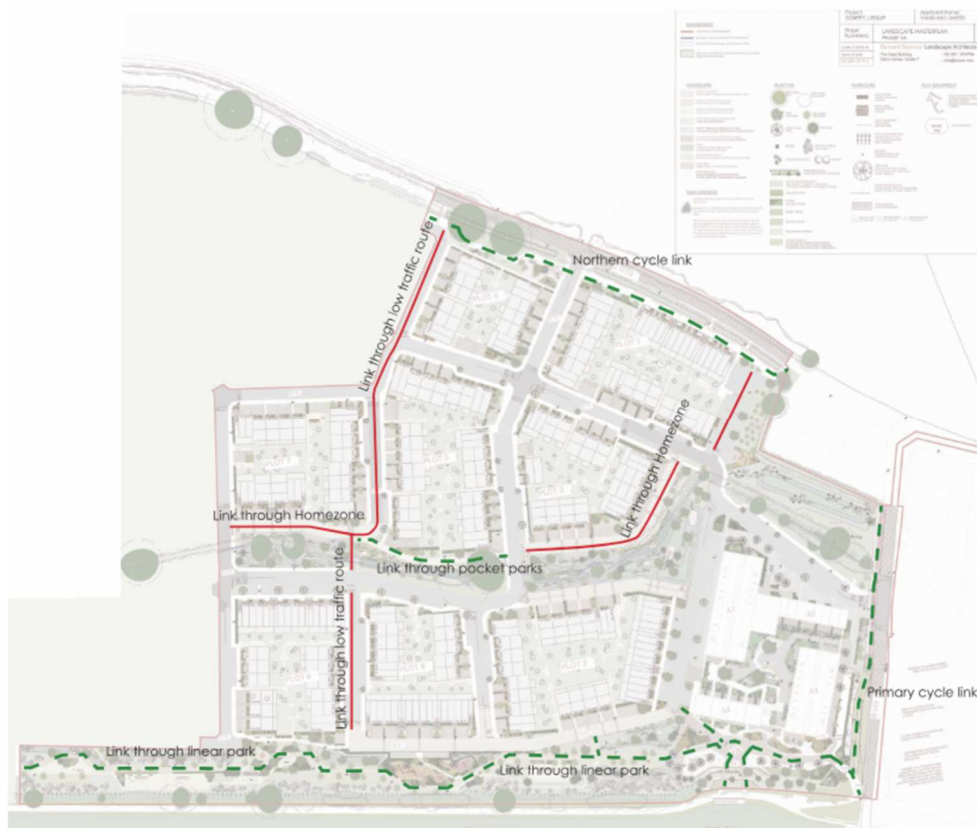
**Figure 1** BSLA VRU routes (source: BSLA)

The Applicant's landscape Architect, BSLA, has provided a response under separate cover in relation to the same and an extract is provided in **Figure 1** below.

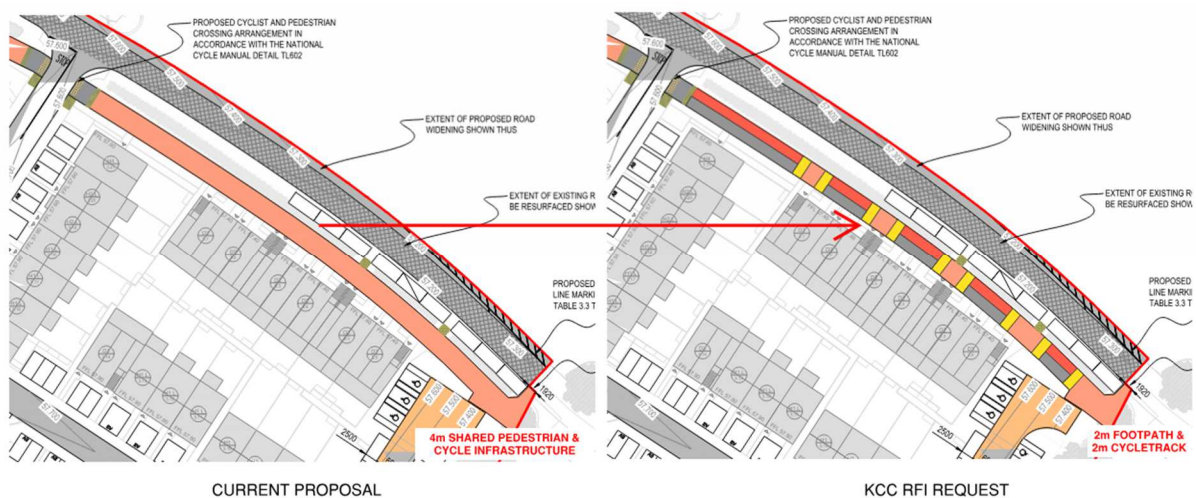
**Figure 2** 4.0m wide Active Travel Infrastructure proposed as part of the subject application (source: DOBA drawing 2423-DOB-XX-SI-DR-C-0500)

The proposed development, as part of the Phase 1A of the Confey Masterplan, provides for a continuous 4.0m wide shared pedestrian and cyclist infrastructure along the L1015 as illustrated in orange in **Figure 2** below in lieu of separate 2.0m wide footpaths and 2.0m wide cycle tracks and the reason for this is clear. If separate footpaths and cycle paths are provided, these will require tactile paving and shared surfaces to access the duplex units fronting onto the L1015 at unrealistic and impractical intervals as can be seen in the comparison in **Figure 2** below.

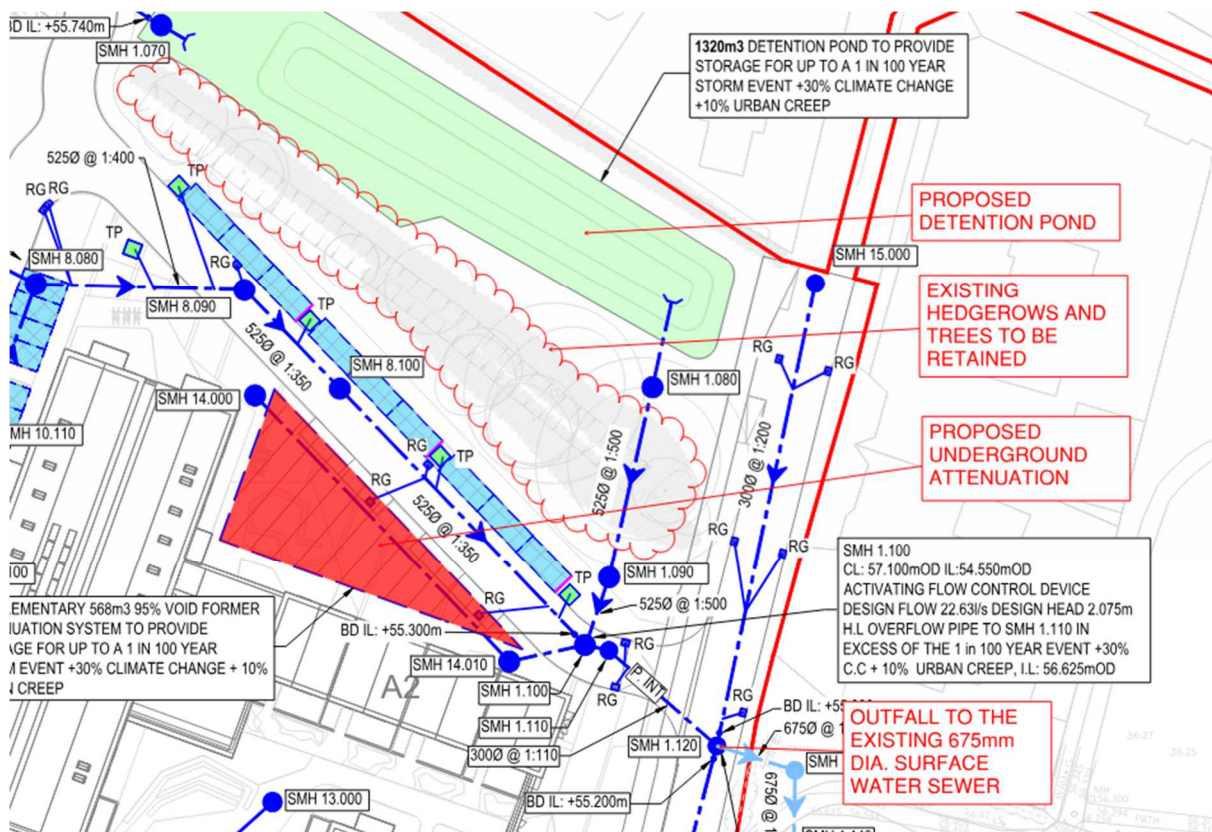
**Figure 3** Attenuation features & constraints at the outfall

The design solutions and proposals to try and completely omit any underground attenuation on the site have been exhausted as noted above. The constraints noted in addition to the site levels, outfall levels, and the requirement to accommodate storage for all events up to a 1 in 100 year + 30% Climate Change event plus additional 10% Urban Creep factor through the site all factor in the attenuation provision.

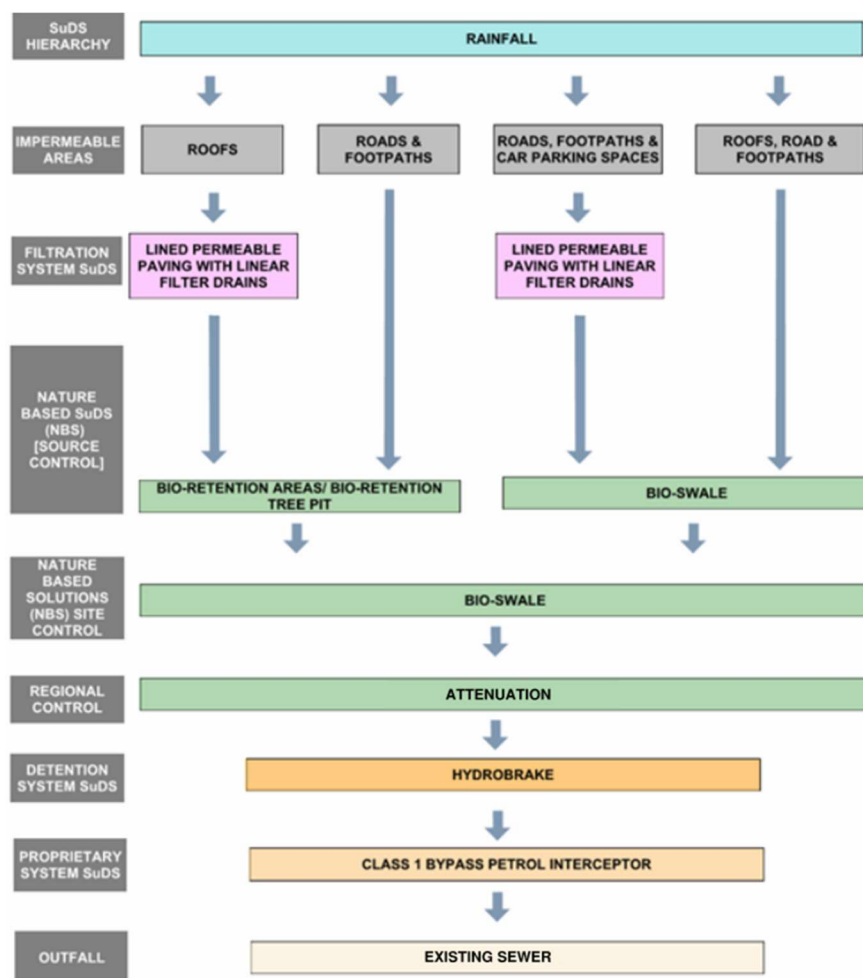
**Figure 4** Proposed Typical Sub-Catchment Treatment Train

The proposed design provides a **minimum** 2-stage surface water treatment process which intercepts surface water run-off at source and treats the water by filtration and treatment through natural material prior to discharging to the existing surface water network traversing the GAA club to the east prior to discharging to an existing Oranstown watercourse. **Figure 4** below is an extract from the DOBA Infrastructure Design Report (IDR) report 2423-DOB-XX-SI-RP-C-0001 which was submitted as part of the planning application documentation illustrating the proposed treatment train.

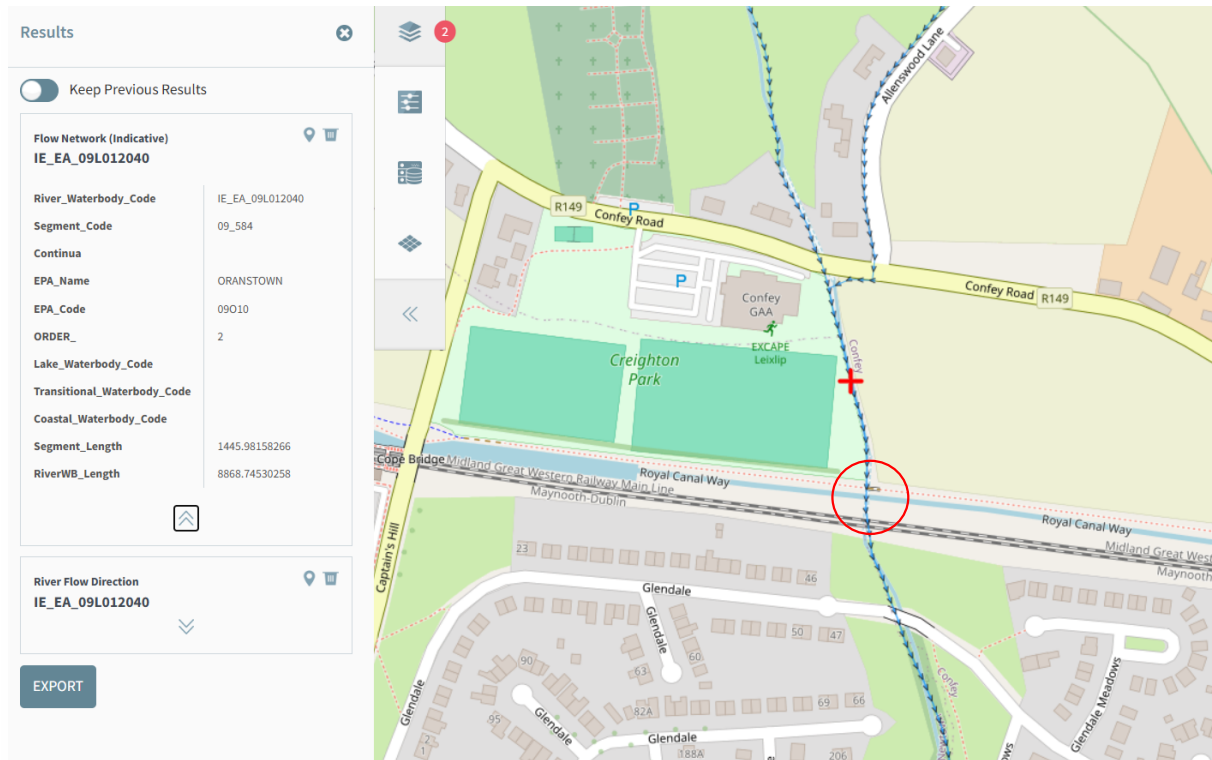
**Figure 6** Flow of Oranstown stream beneath the Canal (source: <https://gis.epa.ie/EPAMaps/Water/>)

Secondly, the existing site drains to the Oranstown Stream via the existing 675mm dia. surface water sewer beneath the Confey GAA lands. The existing Oranstown Stream does not discharge to the Canal as evident via an extract from the EPA river flow network in **Figure 6** below. The proposed development is simply discharging flows through this existing connection and written consent is therefore not required. Thirdly, the proposed discharge has been reduced to pre-development greenfield rates, therefore, this is no additional flow from the proposed development compared to the existing. Additionally, the Applicant liaised with Waterways Ireland and as per the DOBA IDR submitted as part of the original planning application, Waterways Ireland has no objections to the same.

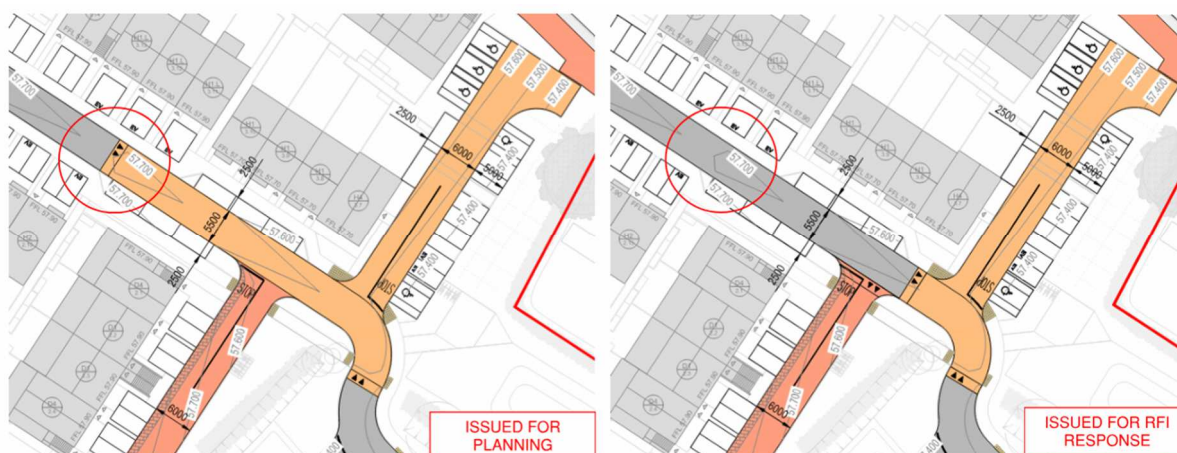
**Figure 7** Comparison of a typical example of table top/ ramped infrastructure revised to avoid impeding residential access or conflict with ramped slopes (source: DOBA Pr. Site Layout Revision P.10 versus P.11)

The Applicant has amended the Proposed Road Layout Plan with particular attention to the positioning of the tabletop/ ramped infrastructure to ensure that no residential access is impeded or conflicts with the ramped slopes. DOBA drawing 2423-DOB-XX-SI-DR-C-0500-S2.P11 Pr.Site Layout has included in **Appendix H** of this report and a comparison of the planning issued and updated RFI response layout are presented in **Figure 7** below.

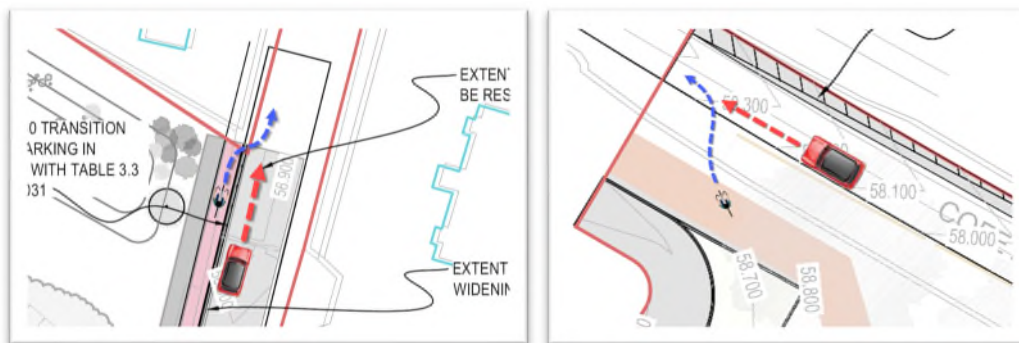
When cyclists reach the end of the segregated cycling tracks, they will merge into adjacent traffic lanes unexpectedly, which could increase the risk of them being struck from behind by approaching vehicles.

**Figure 2.1 – Locations of Where Cyclists Will Be Required Transition Back into Traffic Lanes**

Cyclists should be provided with a safe and appropriate means to transition back into the adjacent traffic lane. The measures should highlight to drivers the location where cyclists will be re-entering the traffic lane in front of them.

| Problem Reference<br>(Section 2) | Designer Response Section | | | Audit Team Response Section |
|---|---|---|---|---|
| 2.1 | YES | YES | <p>Along the East of the site, a transition arrangement in accordance with The Cycle Design Manual is provided in the interim, prior to the completion of the Confey Masterplan and associated future road upgrade. Upon completion of the masterplan, dedicated cyclist and pedestrian facilities will be developed further.</p> <p>Similarly, In the Interim and prior to the Confey Masterplan being completed, a shared surface with tactile paving and dropped kerb is provided for a transition to the carriageway.</p> | Comment noted. |

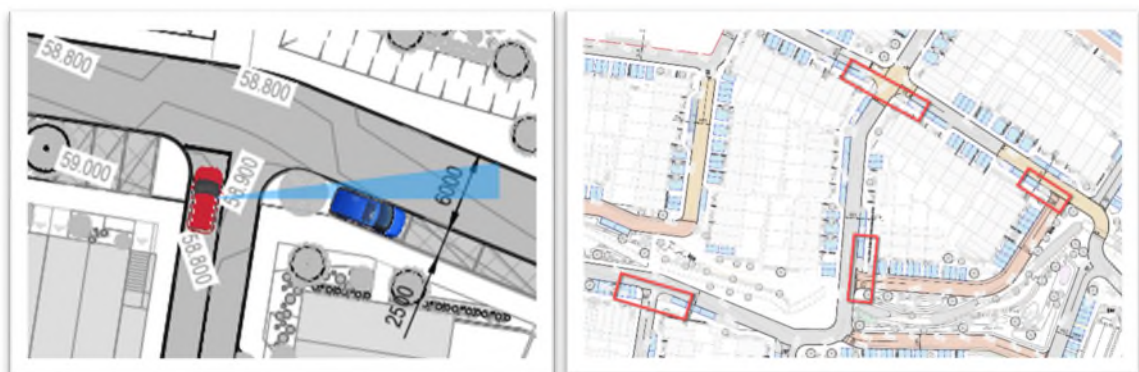
Parking bays positioned too close to internal junctions may reduce visibility splays, increasing the risk of side impact type collisions on the internal streets.

**Figure 2.2 – Examples of Internal Junctions with Parking Close By Which Might Impact on Sightlines**

Sightlines for all internal junctions with parking close by should be examined, with the parking arrangements modified as appropriate to achieve suitable sightlines.

| Problem Reference<br>(Section 2) | Designer Response Section | | | Audit Team Response Section |
|---|---|---|---|---|
| 2.2 | YES | YES | <p>Parallel Parking along carriageways have been relocated/ amended to accommodate suitable visibility splays</p> | Comment noted. |

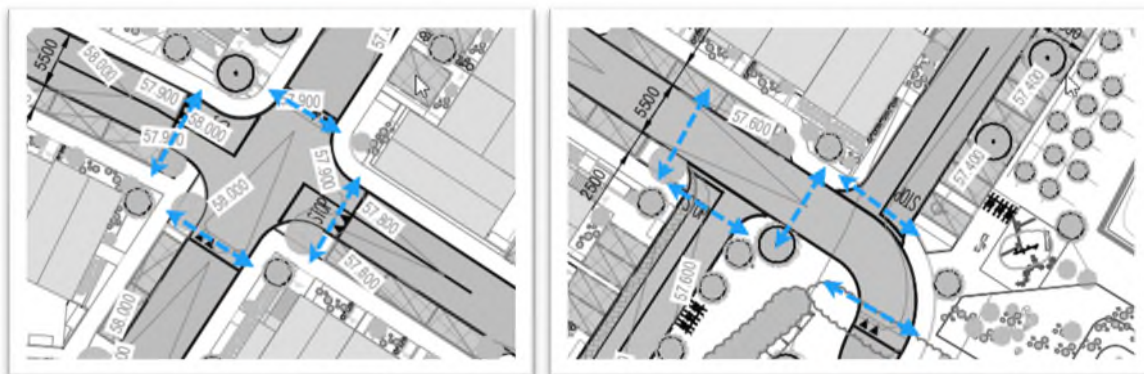
At a number of internal junctions there appears to be an absence of crossing facilities. This could lead to pedestrians attempting to cross the road at unsuitable locations placing them in conflict with vehicles.

Figure 2.3 – Uncatered Pedestrian Crossing Desire Lines at Internal Junctions

Suitable raised pedestrian crossings should be provided in all locations where pedestrians are likely to want to cross the internal streets.

| Problem Reference<br>(Section 2) | Designer Response Section | | | Audit Team Response Section |
|---|---|---|---|---|
| 2.3 | YES | YES | <p>Additional Pedestrian Crossing points have been added where pedestrians will cross internal streets.</p> | Comment noted. |

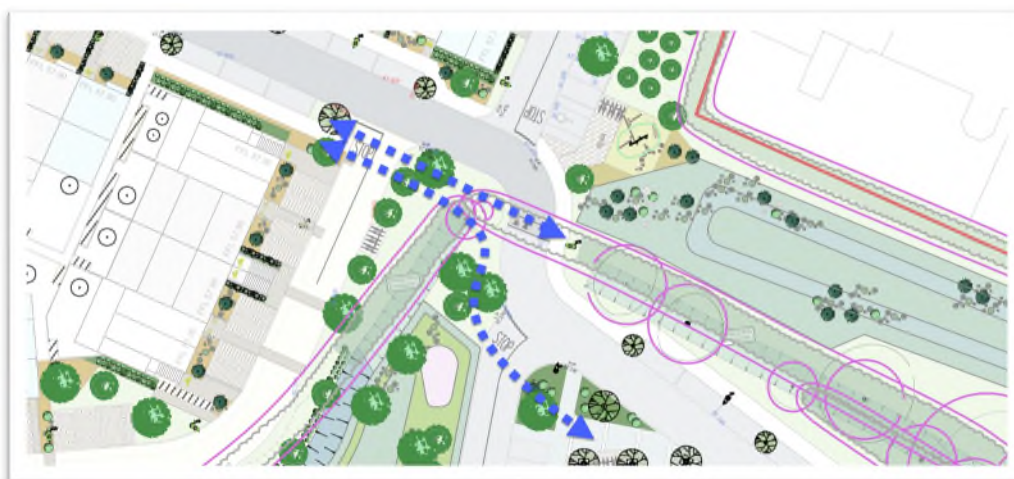
The absence of suitable footpath connections here could lead to pedestrians stepping into the adjacent traffic lane without warning. It could also lead to slips and trips for pedestrians attempting to walk in the grass to reach the nearest available footpath connection.

Figure 2.4 – Missing Footpath Links Near Main Pedestrian Access to Captains Hill / Train Station

Suitable footpath links should be provided here, including raised crossings where required.

| Problem Reference<br>(Section 2) | Designer Response Section | | | Audit Team Response Section |
|---|---|---|---|---|
| 2.4 | YES | YES | <p>Landscaped connection has been provided from the units to the eastern portion of the site</p> | Comment noted. |

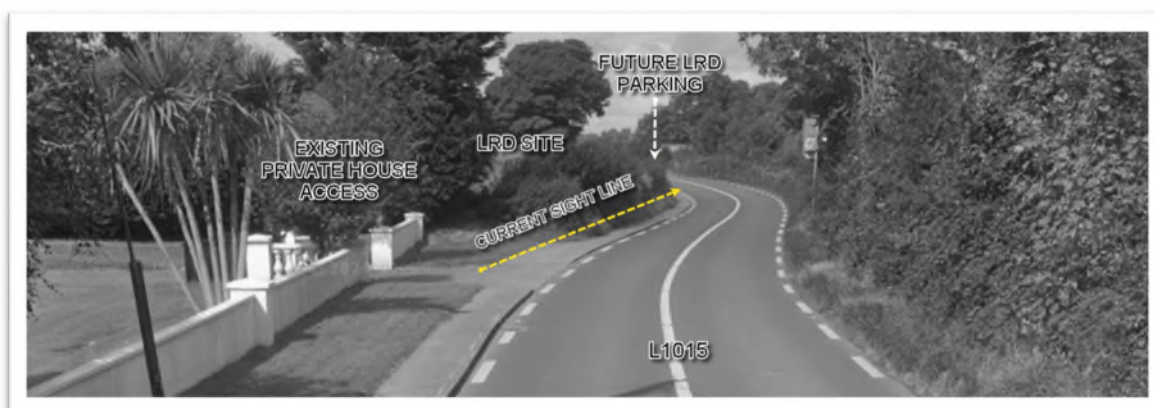
The location of the proposed roadside parking on L1015 Confey Road may reduce visibility for drivers emerging from the house access. This could lead to a collision between vehicles on L1015 Confey Road and a vehicle attempting to leave the house access.

Figure 2.5 – House Access onto L1015 & Location of Roadside Parking to Wset

The Designer should ensure that the proposed roadside parking does not reduce visibility for drivers emerging from the house access.

| Problem Reference<br>(Section 2) | Designer Response Section | | | Audit Team Response Section |
|---|---|---|---|---|
| 2.5 | YES | YES | <p>A Splay of 45m to centre of carriageway is provided in line with DMURS Table 4.2. The proposed Parallel parking is located such that there is no obstruction with Sightlines.</p> | Comment noted. |

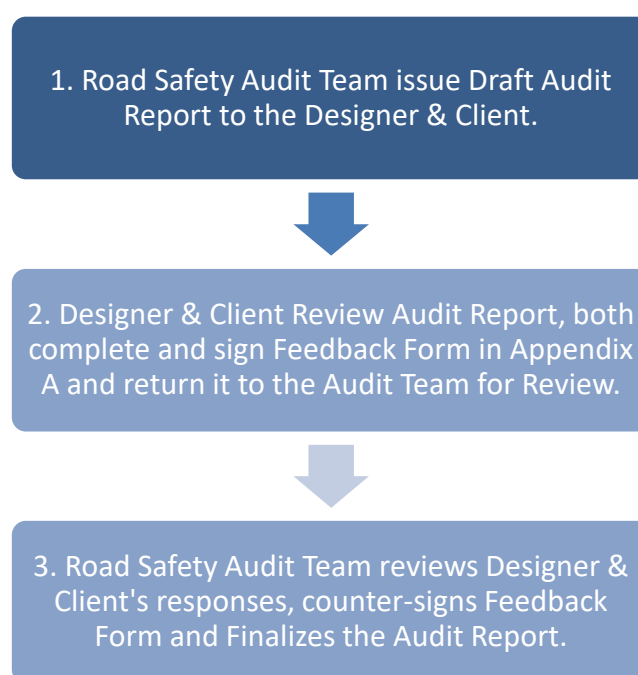
Figure 4.1 – Road Safety Audit Sign-Off and Completion Process

The Designer and the Client should prepare an Audit Response for each of the recommendations using the Road Safety Audit Feedback Form attached in Appendix A.

When completed, this form should be signed by the Designer and the Client and returned to the Audit Team for consideration. See flow-chart following for further description.

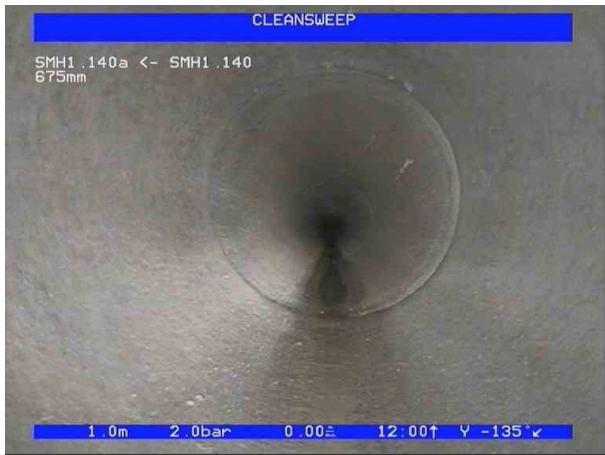
1, 00:00:00, 0.00 m  
Start node, manhole, reference: SMH1.140A

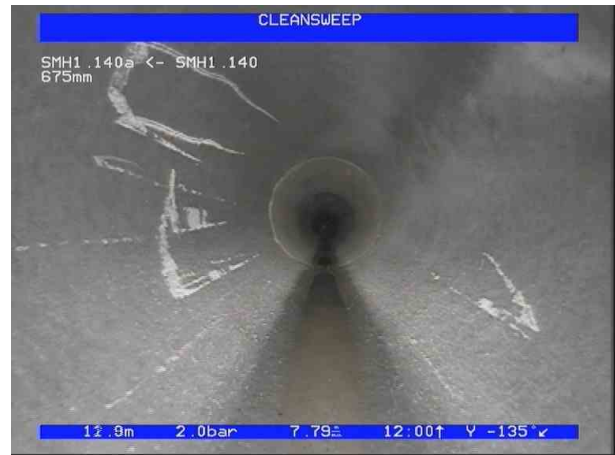
2, 00:01:26, 11.90 m  
General remark, Scrape damage visible

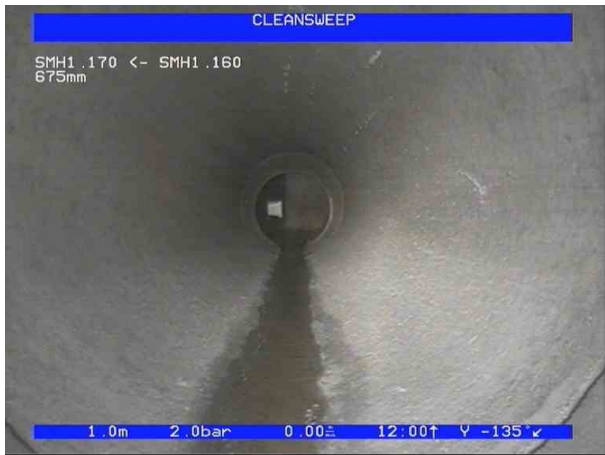
1, 00:00:00, 0.00 m  
Start node, manhole, reference: SMH1.170

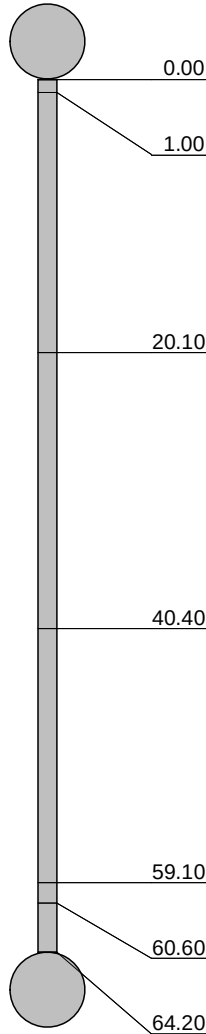
| Scale: | 1:556 | Position [m] | Code | Observation | MPEG | Photo | Grade | | |
|---|---|---|---|---|---|---|---|---|---|
| <div><div><div>Depth: m</div><div>SMH1.170</div></div></div> | | | | | | | | | |
| | | 0.00 | MH | Start node, manhole, reference: SMH1.170 | 00:00:00 | | | | |
| | | 1.00 | WL | Water level, 5% of the vertical dimension | 00:00:00 | | | | |
| | | 20.10 | GP | General photograph taken at this point: Condition Photo | 00:02:12 | | | | |
| | | 40.40 | GP | General photograph taken at this point: Condition Photo | 00:04:15 | | | | |
| | | 60.60 | GP | General photograph taken at this point: Condition Photo | 00:06:17 | | | | |

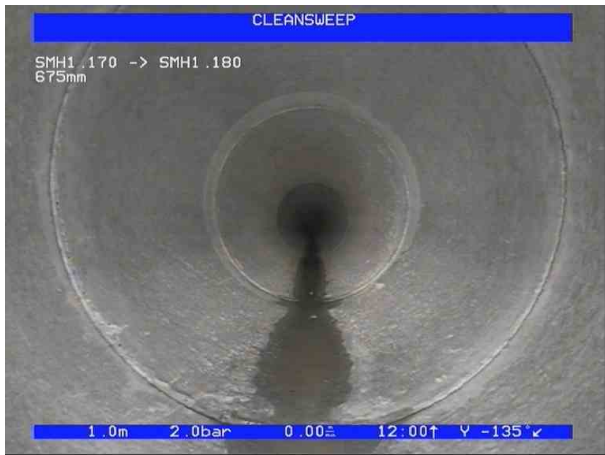
1, 00:00:00, 0.00 m  
Start node, manhole, reference: SMH1.170

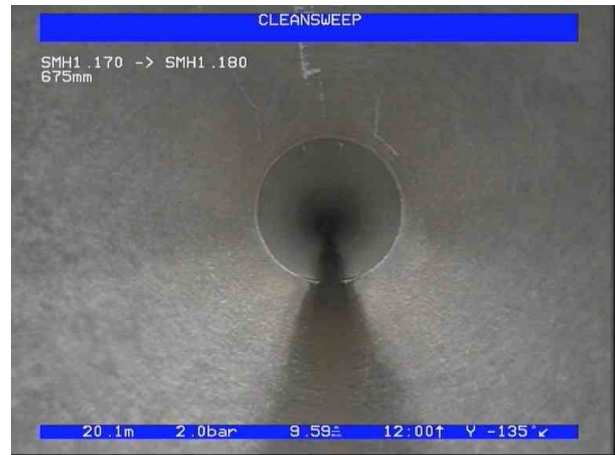
2, 00:02:12, 20.10 m  
General photograph taken at this point, Condition Photo

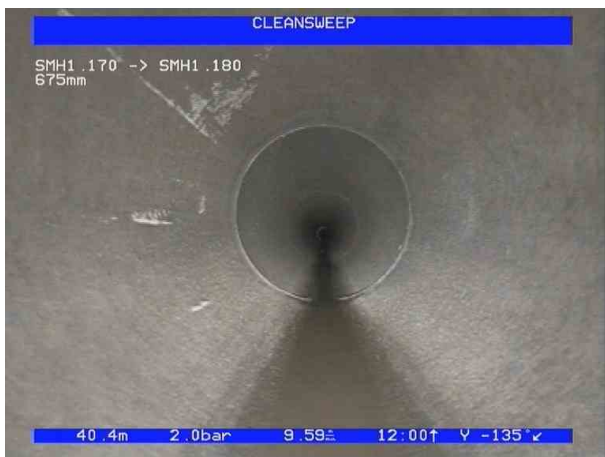
3, 00:04:15, 40.40 m  
General photograph taken at this point, Condition Photo

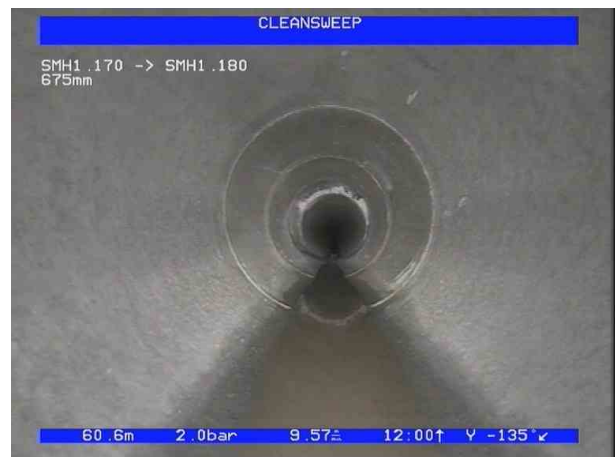
4, 00:06:17, 60.60 m  
General photograph taken at this point, Condition Photo

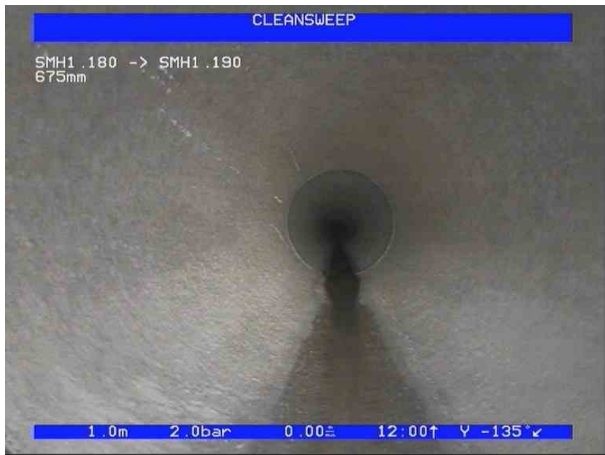
1, 00:00:00, 0.00 m  
Start node, manhole, reference: SMH1.180

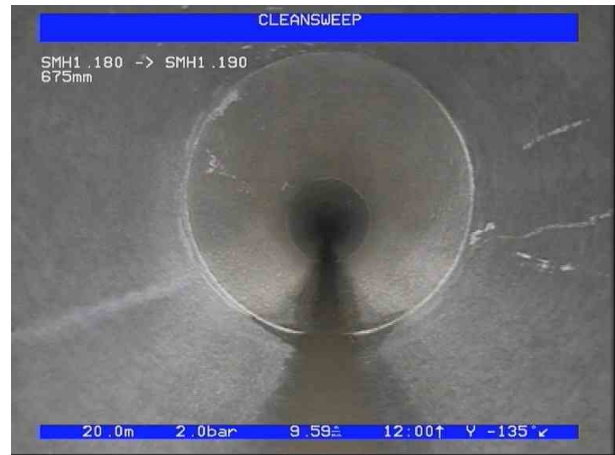
2, 00:02:01, 20.00 m  
General photograph taken at this point, Condition Photo

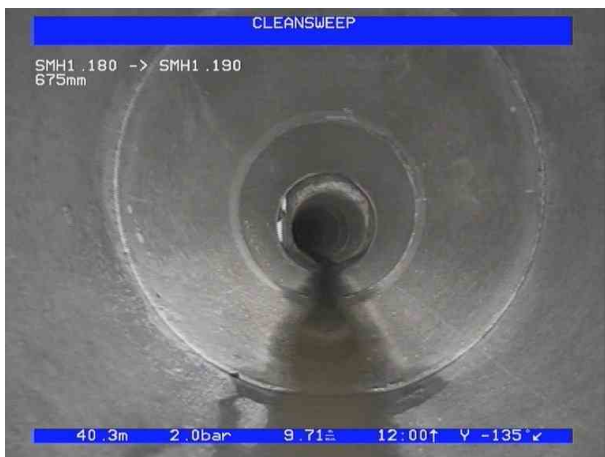
3, 00:04:08, 40.30 m  
General photograph taken at this point, Condition Photo

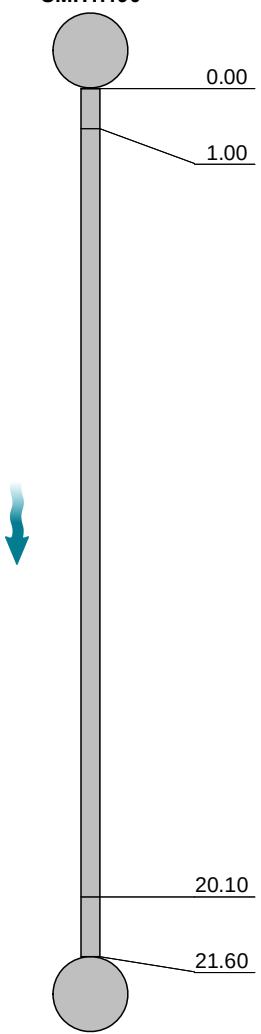
| Scale: 1:188 | Position [m] | Code | Observation | MPEG | Photo | Grade |
|---|---|---|---|---|---|---|
| <p>Depth: m<br/>SMH1.190</p> | | | | | | |
| | 0.00 | MH | Start node, manhole, reference: SMH1.190 | 00:00:00 | | |
| | 1.00 | WL | Water level, 0% of the vertical dimension | 00:00:00 | | |
| | 20.10 | GP | General photograph taken at this point: Condition Photo | 00:01:57 | | |

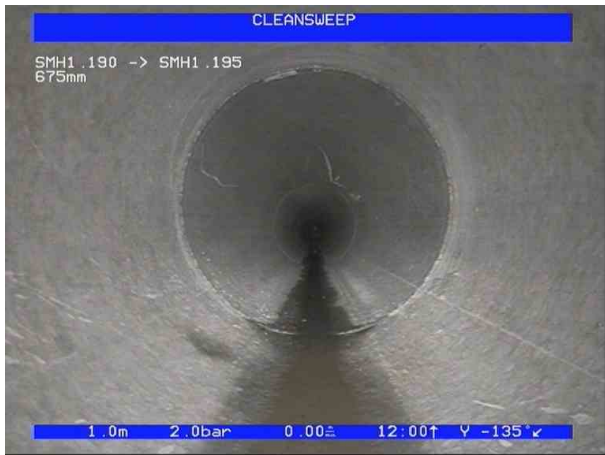
1, 00:00:00, 0.00 m  
Start node, manhole, reference: SMH1.190

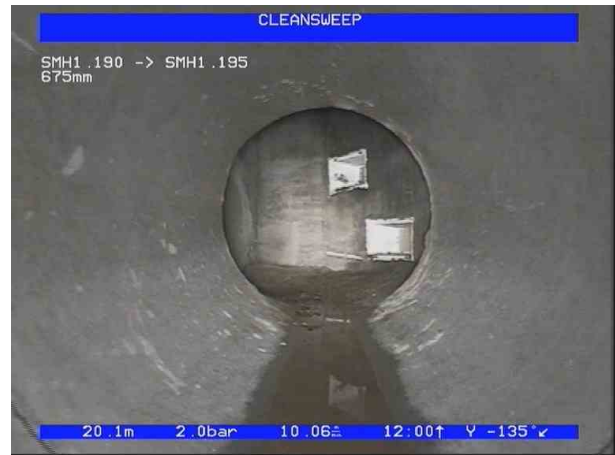
2, 00:01:57, 20.10 m  
General photograph taken at this point, Condition Photo

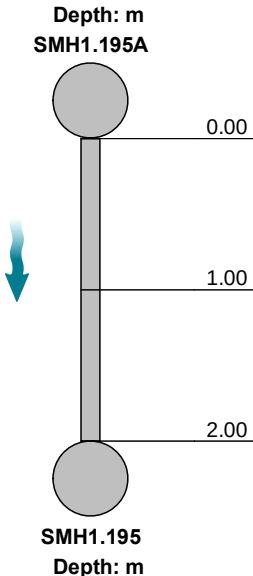
| Scale: | 1:50 | Position [m] | Code | Observation | MPEG | Photo | Grade |
|---|---|---|---|---|---|---|---|
| | | 0.00 | MH | Start node, manhole, reference: SMH1.195A | 00:00:00 | | |
| | | 1.00 | WL | Water level, 0% of the vertical dimension | 00:00:00 | | |

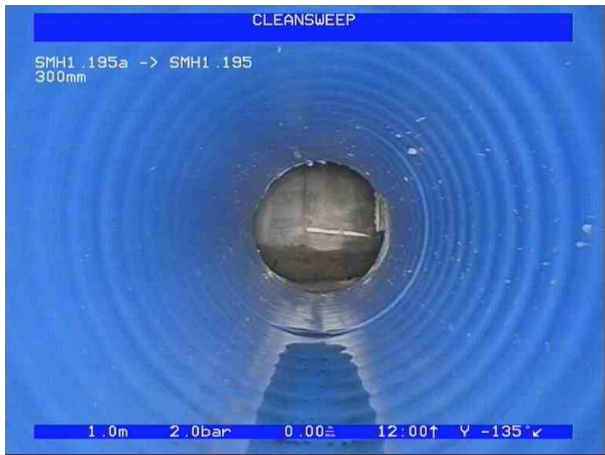
1, 00:00:00, 0.00 m  
Start node, manhole, reference: SMH1.195A

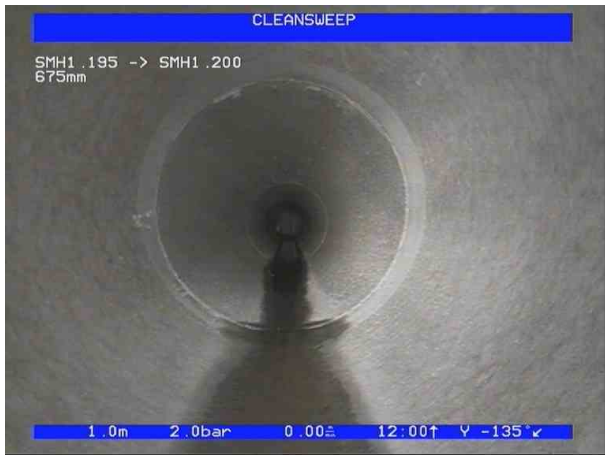
1, 00:00:00, 0.00 m  
Start node, manhole, reference: SMH1.195

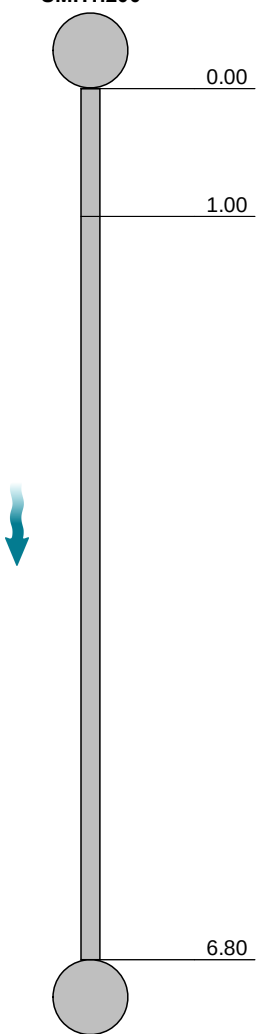
| Scale: | 1:59 | Position [m] | Code | Observation | MPEG | Photo | Grade |
|---|---|---|---|---|---|---|---|
| <p>Depth: m<br/>SMH1.200</p> | | | | | | | |
| | | 0.00 | MH | Start node, manhole, reference: SMH1.200 | 00:00:00 | | |
| | | 1.00 | WL | Water level, 5% of the vertical dimension | 00:00:00 | | |

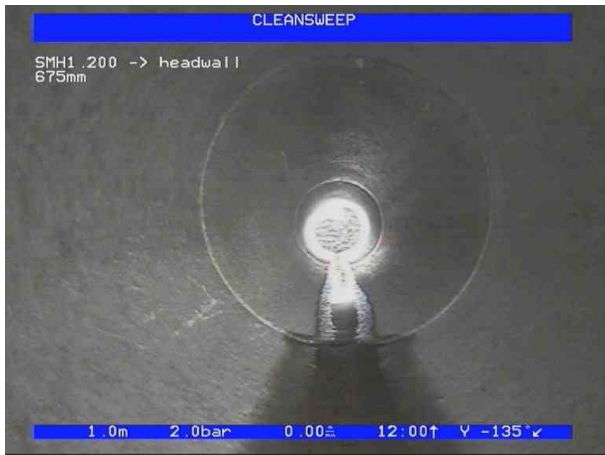
1, 00:00:00, 0.00 m  
Start node, manhole, reference: SMH1.200
